Alberta medical center needed duct cleaning before opening

Three years of construction at an Edmonton, Alberta, diabetes research facility had left the building's HVAC and closed-loop high-efficiency air filtration systems full of dust.

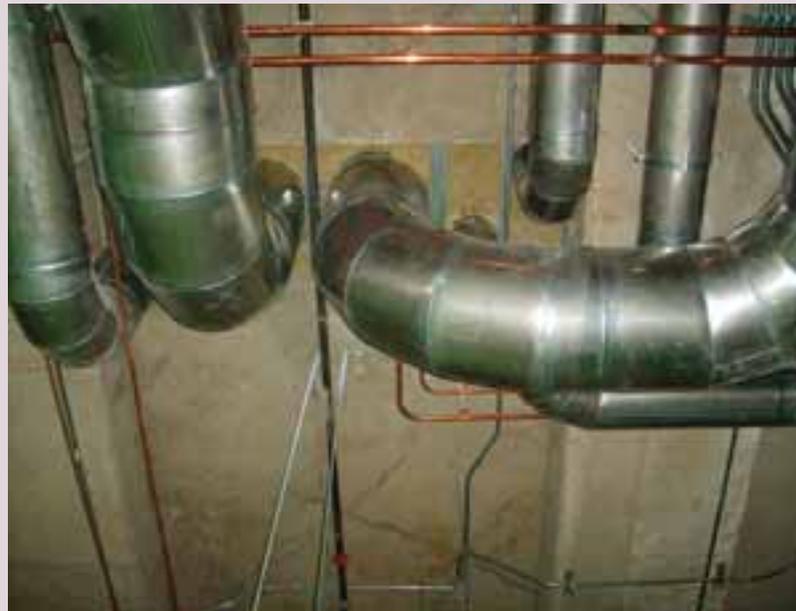
A look at the stainless steel ductwork from the floor. Much of the ductwork was hidden behind concrete.

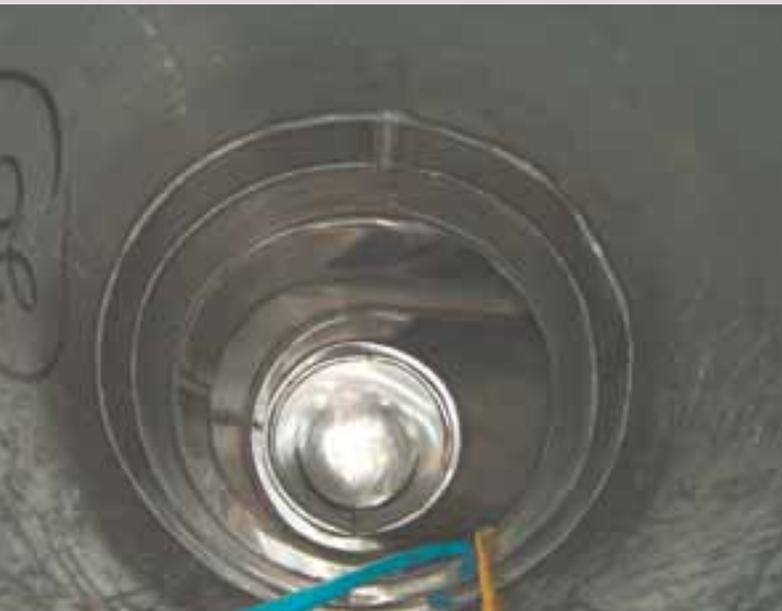
Before the HVAC was to be turned on for the first time, the architect demanded it be cleaned up. The project wouldn't be easy. The problem wasn't just getting to the ductwork — the filtration systems for each laboratory were made of TIG-welded stainless steel tubing with limited access. The system used multiple branch lines up to 60 feet long. Most ducts were installed behind painted gypsum wallboard and concrete.

The inside of the ductwork in the medical facility before Lloyds Systems' was able to clean it. Note the whip marks in the remaining dirt.

Lloyds Systems of Rapid City, S.D., was contacted to see if it could help. The company is well known for using robotics to tackle difficult commercial and industrial indoor-air-quality problems. Its engineering team decided the best approach was to use a compressed-air-driven axial-rotating remote control robotic brush, which would ensure the entire duct surface was cleaned. It delivers $\frac{1}{2}$ horsepower at 90 pounds per square inch — enough to remove the debris.

As the cleaning was under way, an on-board digital video system recorded the procedure. A handheld version of the robotic system was used to clean the smaller chases.
